Urban Stream Restoration Protects Access Road

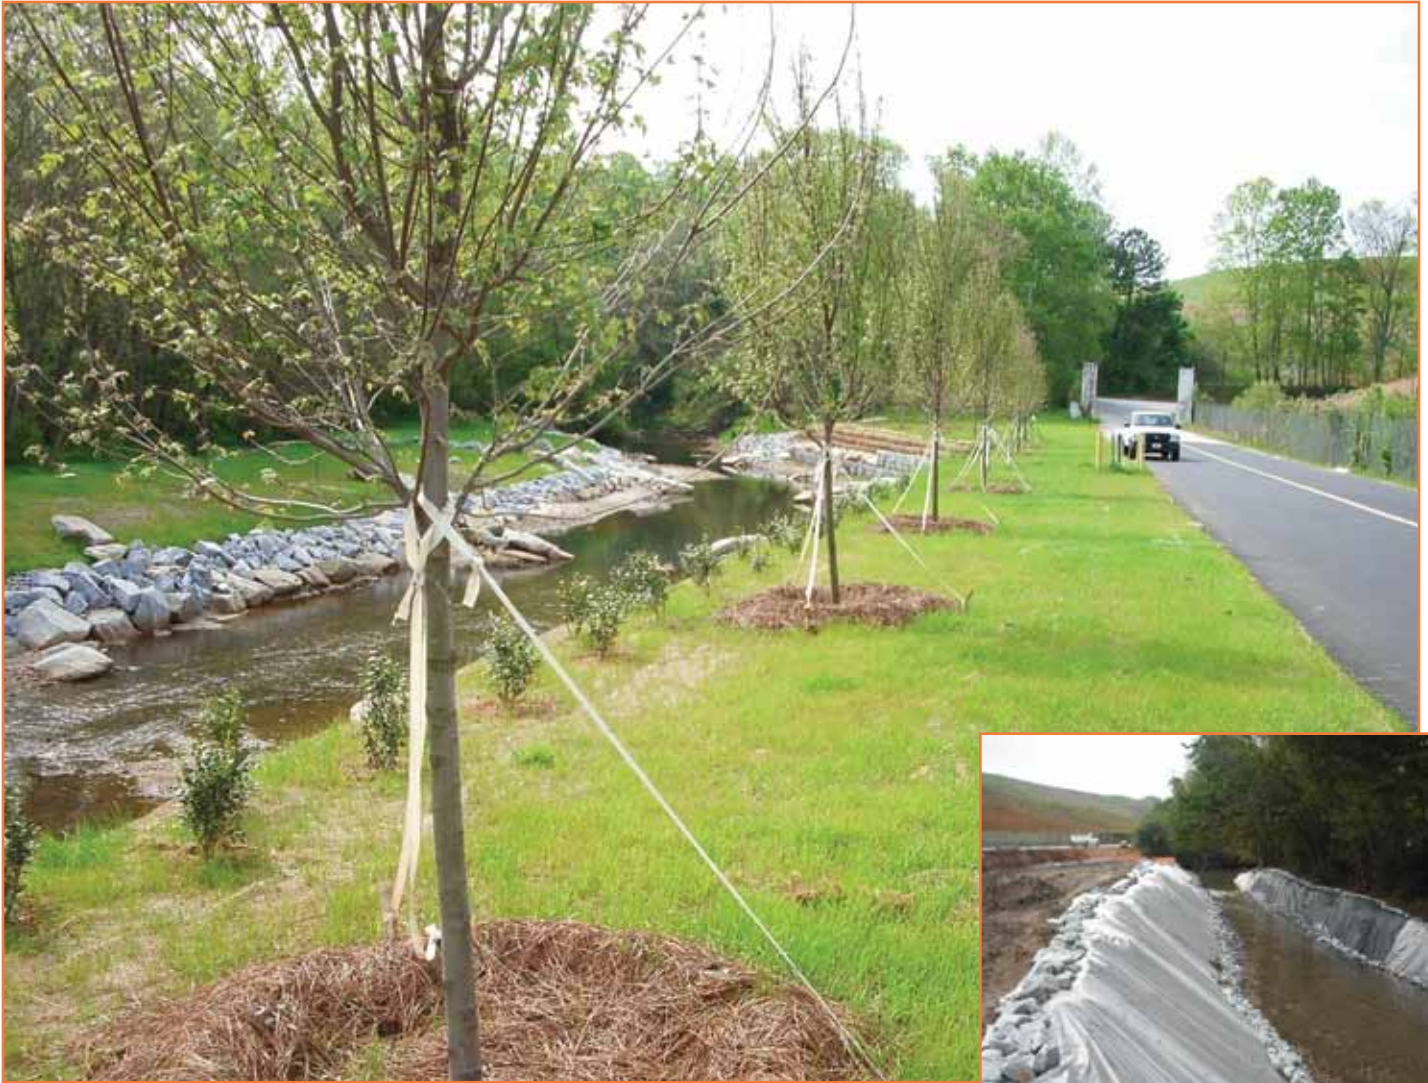
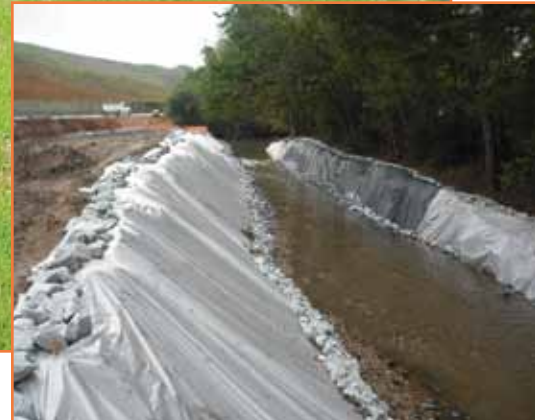
The non-woven fabric would prove durable enough to last until flow was transferred back to the main channel five months later.

construction in early August 2008. The first step of construction was a temporary by-pass channel for Intrinchment Creek. Working downstream to upstream, an 800 ft long bypass channel was excavated by removing 3000 cubic yards of dirt. Before flow was transferred into the temporary by-pass channel, the newly excavated area was lined with a 6 mil plastic liner. However, after about two weeks of usage, it was obvious the thin plastic liner wasn't able to withstand rain events and was already tearing. Portions of the stream flow were threatening to undermine the liner entirely. The decision was made to switch to 180EX, a non-woven geotextile fabric from Thrace-LINQ, Inc., manufactured from polypropylene staple fiber. The geotextile was installed during a low-flow event one 10 foot section at a time. The non-woven fabric would prove durable

enough to last until flow was transferred back to the main channel five months later.
